Subject Property: Woodland Altars Campground

APPRAISAL OF REAL PROPERTY

33200 State Route 41 Peebles, OH 45660 See Attached

\$\$2,012,000

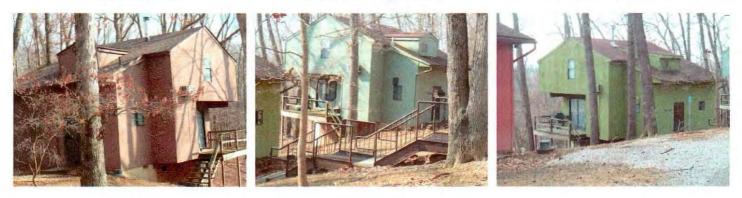
Chalet G

Chalet H

The subject has five (5) individual chalets that have been used for housing for camp use as well as they are rental units during hunting season. Each chalet has three (3) bedrooms, two (2) bathes, kitchen and living room/dining room combination. Heat and air conditioning are by wall units with each chalet having a wood stove.

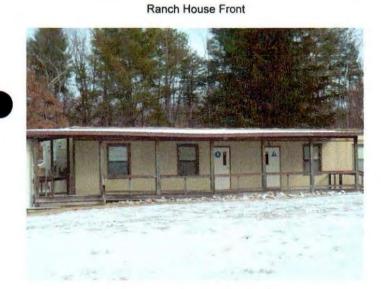
Ranch House Modular Bath House

The area near the intersection of SR 41 and Conaway Road is known as the Ranch House area. There is a 2016 square feet frame dwelling, an old frame 1152 square feet shop building, a 1536 square feet modular dormitory, an 1144 square feet modular bath house and a 1008 square feet limited contributory pole shed. These older building are in fair condition with the modular in average condition.

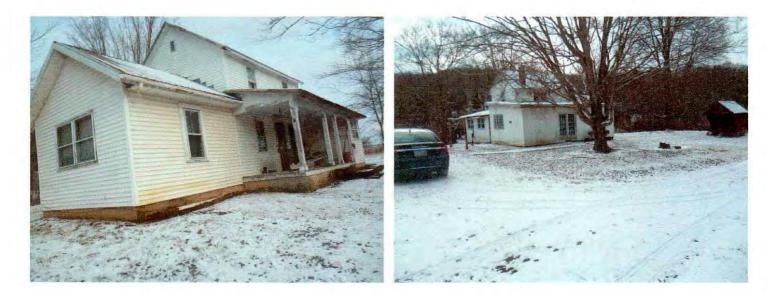
Staff House Front

Staff House Rear

An older set of buildings on the east edge of the property known as the staff house area includes a 1472 square feet older farm house, a 2160 square foot barn with a 864 square foot lean to and a 648 square foot lean to attached and an old non-contributory chicken house and non-contributory garage. These buildings are all only in fair condition.
